**MULTI-FAMILY
HOUSING**
CLIMATE ZONE 4

Controlling Humidity in Affordable Multi-Family Housing for Health, Comfort and Property Protection

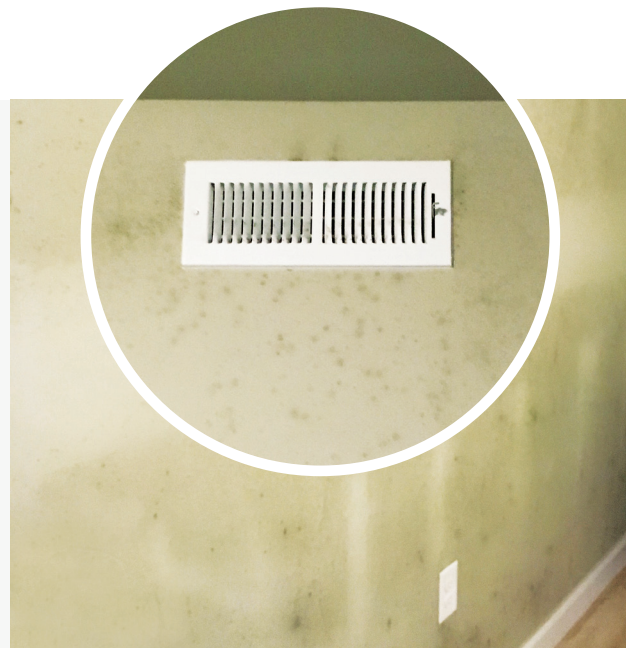
Microbial growth on the walls prior to the installation of an Ultra-Aire MD33 In-Wall Dehumidifier.

As it turned out, the two-ton condensing systems were grossly oversized for the one-bedroom units. Further compounding the problem was the humid air being brought in through the fresh air intake. To try and resolve the issue, tenants kept lowering the thermostats and over-cooling the space. Unfortunately, the lower surface temperature increased the interior dew points to a level where sufficient water activity was present to support microbial growth on the walls.

The tenant was temporarily relocated while the unit was remediated and an **Ultra-Aire MD33 In-Wall Dehumidifier** was installed. Almost immediately, the RH stabilized in the 50% range, with dew point values remaining consistently low, while the interior temperature was maintained at a comfortable and affordable 75° F. The resident reported an immediate difference in the feel of her apartment, with the sticky, clammy feeling she had endured now eliminated. As a result of this success, property management installed Ultra-Aire MD33 In-Wall Dehumidifiers in all of the building's first and second floor units.

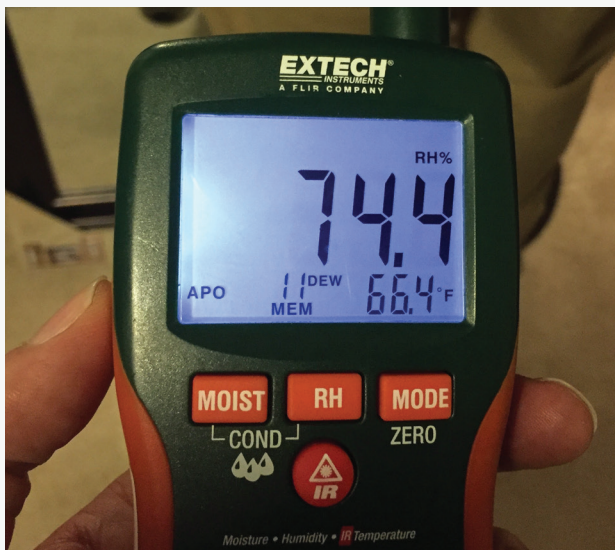
Conditions inside apartment were 74% RH and 66°F.

Following a normal humid summer, the resident of a one-bedroom, second-floor, 700-square foot apartment began noticing mold on the walls of her bedroom, the hallway, and the kitchen. According to the EPA, indoor relative humidity (RH) should be maintained between 35% and 50% for maximum comfort, but the RH in this apartment was measured at 74%. The tenant confirmed that she kept the thermostat temperature set at an uncomfortable 66° F because of how muggy her apartment always felt.
